Contract #: 04-0120F4Cty: SF/ALA Rte: 80 PM: 13.2/13.9File #: 1.28**WELDING INSPECTION REPORT****Resident Engineer:** Casey, William**Address:** 333 Burma Road**City:** Oakland, CA 94607**Report No:** WIR-028752**Date Inspected:** 13-Nov-2012**Project Name:** SAS Superstructure**OSM Arrival Time:** 700**Prime Contractor:** American Bridge/Fluor Enterprises, a JV**OSM Departure Time:** 1730**Contractor:** American Bridge/Fluor Enterprises, a JV**Location:** Job Site**CWI Name:** Fred Michels and Steve Jensen**CWI Present:** Yes No**Inspected CWI report:** Yes No N/A**Rod Oven in Use:** Yes No N/A**Electrode to specification:** Yes No N/A**Weld Procedures Followed:** Yes No N/A**Qualified Welders:** Yes No N/A**Verified Joint Fit-up:** Yes No N/A**Approved Drawings:** Yes No N/A**Approved WPS:** Yes No N/A**Delayed / Cancelled:** Yes No N/A**Bridge No:** 34-0006**Component:** SAS OBG**Summary of Items Observed:**

WELDING INSPECTION REPORT

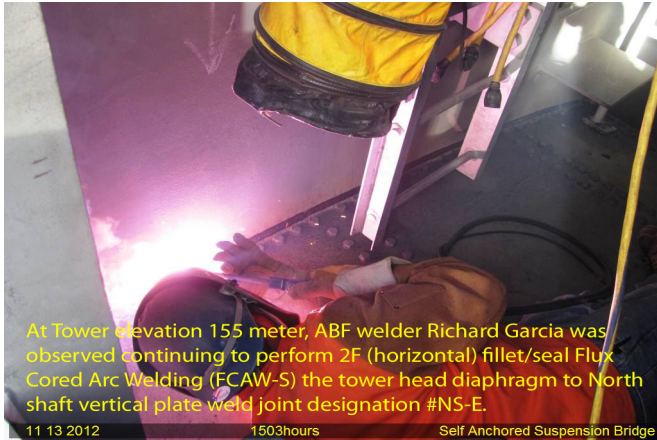
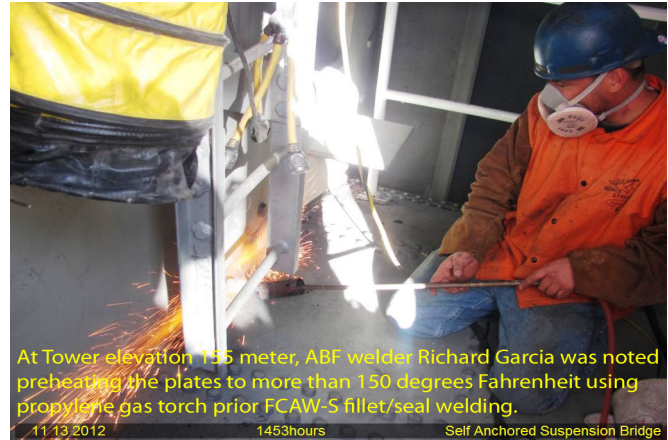
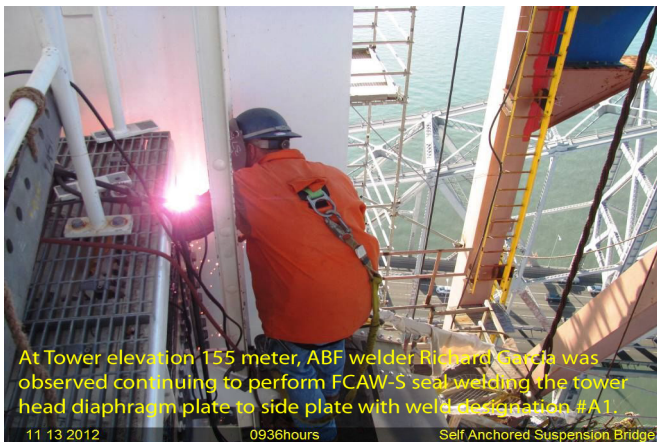
At Tower elevation 155 meters, QA randomly observed ABF welder Richard Garcia continuing to perform seal/fillet welding between the Tower head diaphragm and tower chimney vertical plate weld designation NS-E. The welder was noted welding seal/fillet welding in 2F (horizontal) position utilizing self-shielded Flux Cored Arc Welding (FCAW-S) with 0.072" diameter E71T-8 wire electrode implementing Caltrans Welding Procedure Specification (WPS) ABF-WPS-D15-F2200-2. Prior seal welding, the paint coating on both sides of the joint was ground off and the plates were preheated to more than 150 degrees Fahrenheit. During the shift, QA noted ABF QC Fred Michels was on site monitoring the in process preheats and welding parameters with measured working current of 340 amperes and voltage of 23 volts. At the end of the shift, seal/fillet welding of the Tower head diaphragm to chimney vertical plate inside was completed.

The QAI observe the ongoing installation, field fit-up and tack welding of the utility pipe support lug 5" long x 1" wide x 3/8" thick along the W2 grid line (panel point PP68). The lug pipe support was fillet welded on both sides of the 2 1/2" diameter domestic water line and 4" diameter compressed air line. The QC inspection was performed by Steve Jensen utilizing the Welding Procedure Specification (WPS) identified as Fillet Murex to monitor the tack welding and fillet welding to verify the welding parameters. The welding parameters were observed and

recorded as 88 amps utilizing 2.4 mm electrodes with the welding performed in the 2F/4F positions. The tack welding/fillet welding was performed and completed by FW Spencer welder Damian Llanos. At the end of the shift, two (2) support lugs welded on each line were completed.
